Downie's Cottage, Braemar

Repairs and upgrades to a Highland cottage

This publication should be quoted as:
Historic Environment Scotland
Refurbishment Case Study 22

Roger Curtis

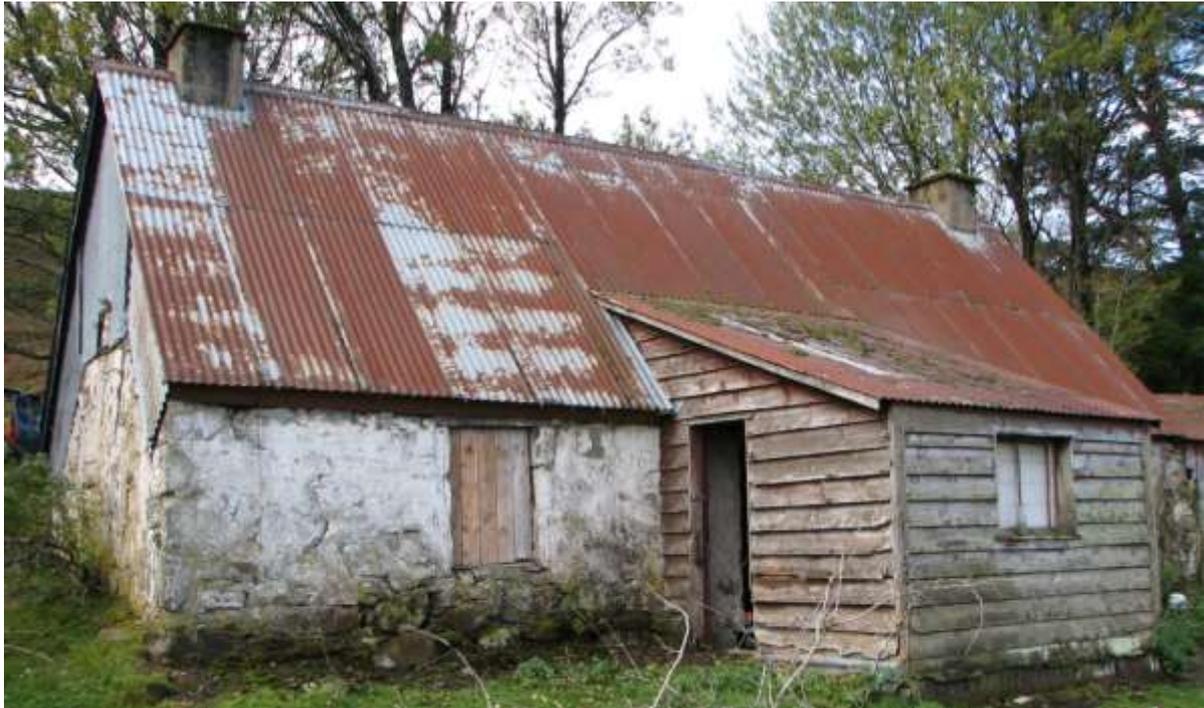
Figure 4. The Croft house in 2011 prior to the refurbishment. The corrugated iron roof covering is of relatively recent date but has largely ensured the survival of the building and the heather thatch beneath.

The galvanised corrugated iron was in satisfactory condition considering its age. The thatch underneath, which is an important part of the history and significance of the building, was left in-situ. Occasional fastenings were replaced, and the wires that held the roof to the walls were refastened and replaced as necessary with a heavy 12 gauge fencing wire. The existing corrugated iron was retained, with localised repairs. It was then cleaned with a wire brush, treated with a rust stabiliser and painted with a 2 part epoxy paint in a traditional 'red oxide' colour.

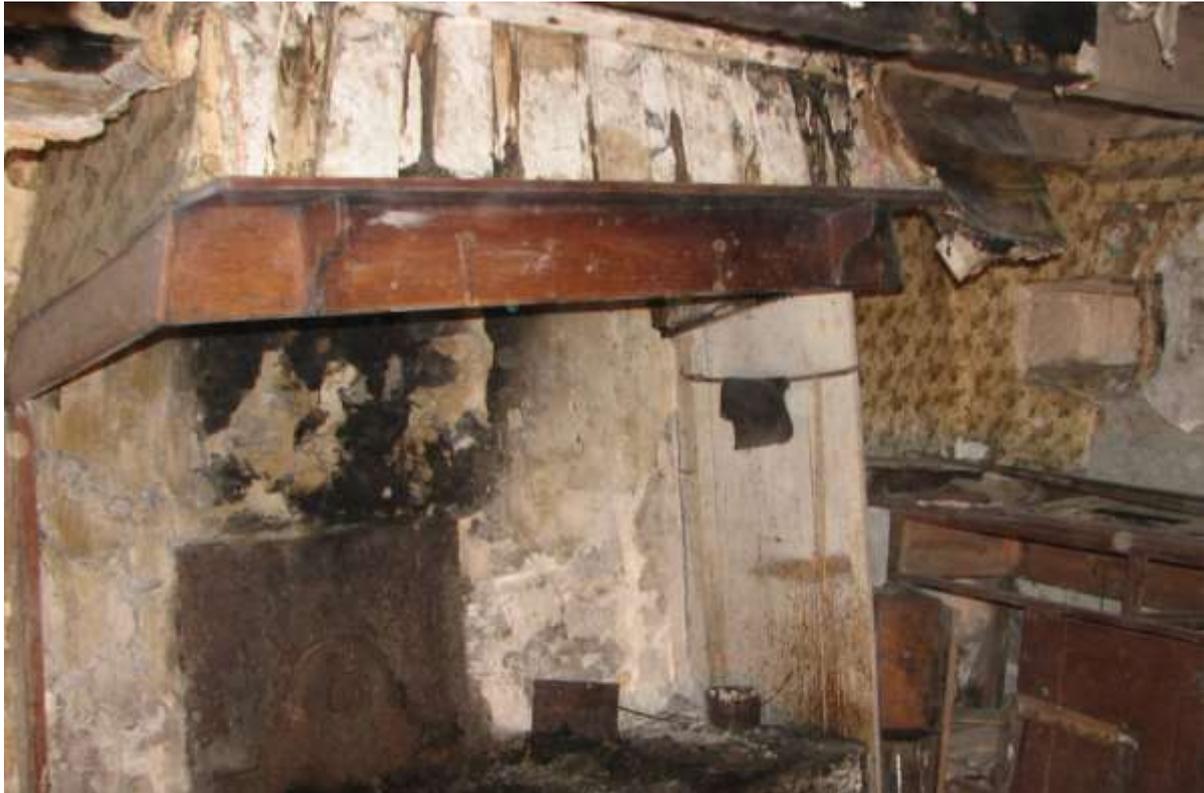
Figure 9. The hanging lum in the kitchen prior to works; a very rare survivor of a once common feature in rural homes.

Whilst one of the most interesting and significant features of the building, it only required modest repair, mostly associated with the fitting of an insulated flue liner. A double-skinned sectioned flue liner was used, following the line of the existing timber lined flue. The void between the liner and the flue interior was left clear; some modern practice requires this to be filled with a granular filler, but this is not appropriate in traditional flues of timber or masonry.

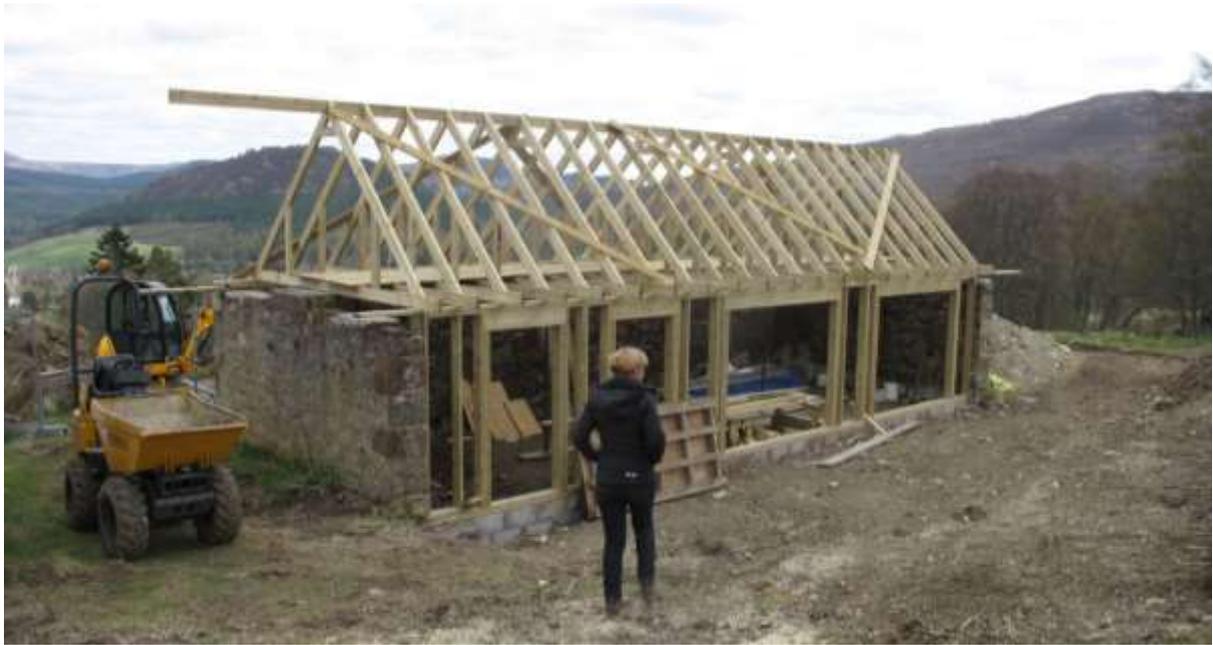
The byre, shown in various stages of construction in the early photographs, was entirely ruined, although the masonry walls were standing to the eaves height and the stone appeared sound. The repair of this building was important as the croft house was so small, much of the services, plant and equipment, as well as storage had to be located outside the house, the byre being of a good size and suitable location. Furthermore, the retention of this structure provided historical context for the croft house. Accordingly, it was decided to re-roof the building and use it to house the heating plant, water storage/treatment and provide utility space for the croft and for other storage. Despite having been open to the weather for some time, the masonry was in good condition, and only minor works were required.

Figure 15. The new roof structure on the byre.

A design for the roof and the open side to the south was straightforward and the reconstruction of this building was begun first to give a storage facility for the construction work on the croft house (Figure 15). The roof timbers were grade C16 softwood, with trusses of standard dimension made up on site. This allowed the slight changes in level of the existing masonry to be easily accommodated. Roof construction on traditional buildings is structurally simple and proven; pre-manufactured trusses are not necessary, even on much larger buildings. The chosen roof covering was corrugated iron, of traditional profile (sinusoidal). The roof was painted with a 2 part epoxy based system, of traditional colour to match the croft house roof.

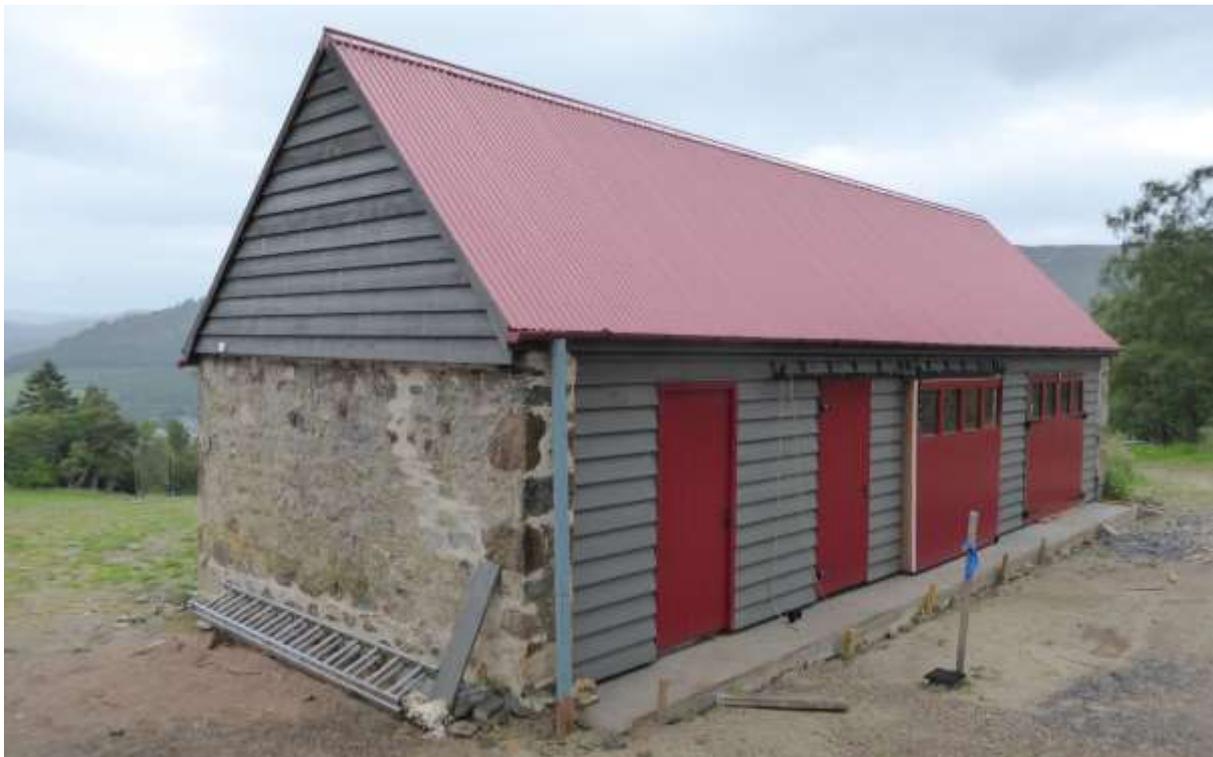
Figure 16. The restored byre with new doors and roof, blending in well with adjacent structures.

The byre had always been open to the south for the storage of agricultural equipment, but as an enclosed space was required a new timber front was designed, with large opening doors. The design and construction was simple and easily assembled, using standard timber lengths and fastenings. This gave a useful enclosed space that was entirely consistent in spirit to the croft house, and to other buildings in the vicinity (Figure 16).

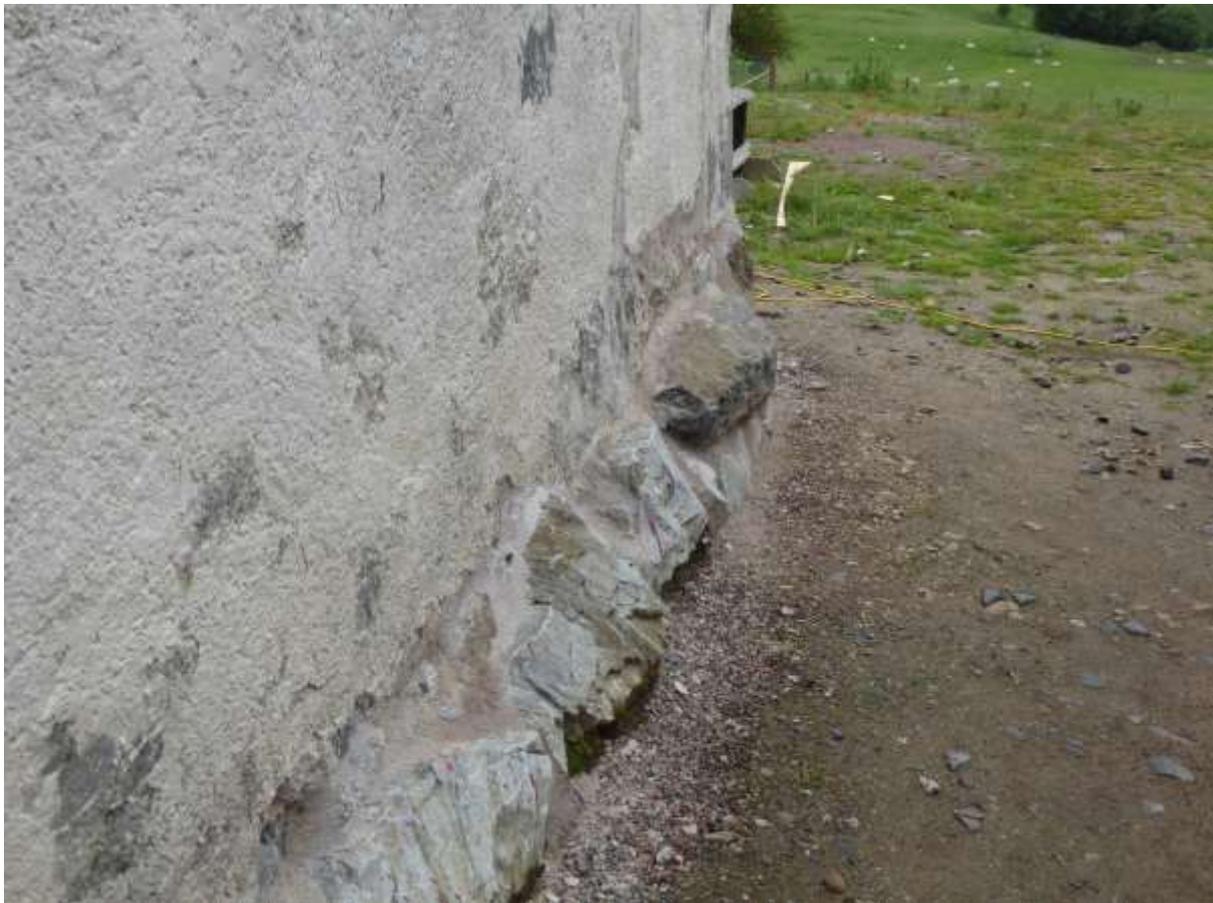
Vernacular buildings of this type do not have foundations as they are understood today; the thickness of the walls increases the footprint and mean that the pressure on the ground is modest. Typically, to provide support to the fabric a base course of large stones is usually set into the ground, to a depth of a 300 mm (Figure 17), often a few inches wider than the above ground wall. However, at Downie's it was in places less. While this can be alarming to those from a modern construction background, it is generally sufficient. At the cottage, this base course occasionally touched bedrock and the walls were stable and in most areas the foundations required only simple re-pointing. However, the northwest corner was on a glacial gravel and there had been some settlement (the wall collapse at the southwest end was largely due to issues with the ditch and tree roots).

Figure 17. The foundation stones at the base of the wall.

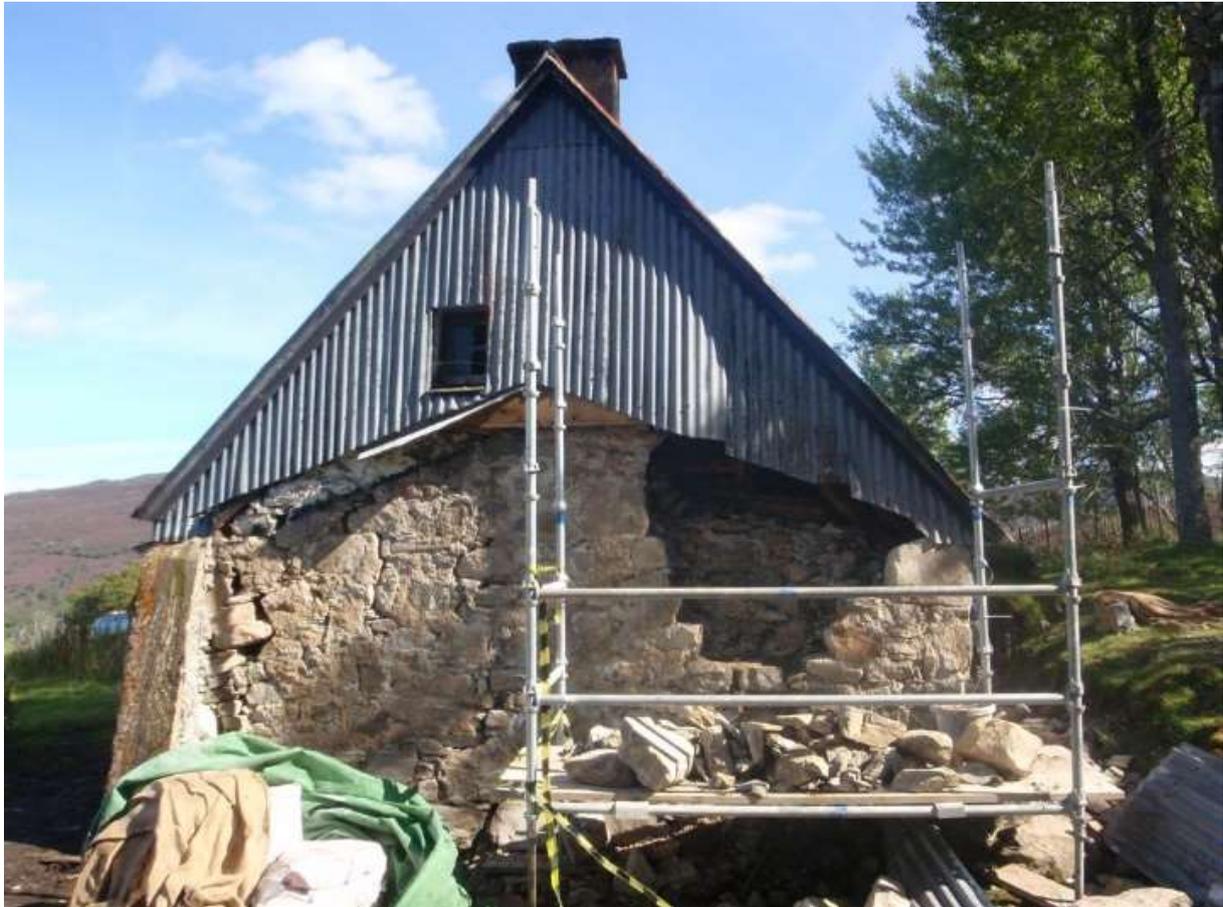
While the roof was in good condition, external ground conditions had led in some areas to settlement of masonry and collapse. This settlement appeared to be from 3 causes: poor drainage behind the house and a build-up of soil and organic material against this elevation causing leaching and decay of the lime mortar; fallen limbs

from the trees; and on the southwest gable and corner where the bedrock changed to glacial gravel resulting in a poor foundation. Half of the rear wall was rebuilt with salvaged stones and a lime mortar. While at first sight in satisfactory condition, the west gable was not stable, and previous buttressing indicated that there had been problems here for some time. The gable end was dismantled and rebuilt (Figure 18), including the existing flue. Other areas of the masonry walls were repointed with a hot lime mix, and finished with limewash.

Figure 18. Rebuilding work on the west gable wall in 2013.

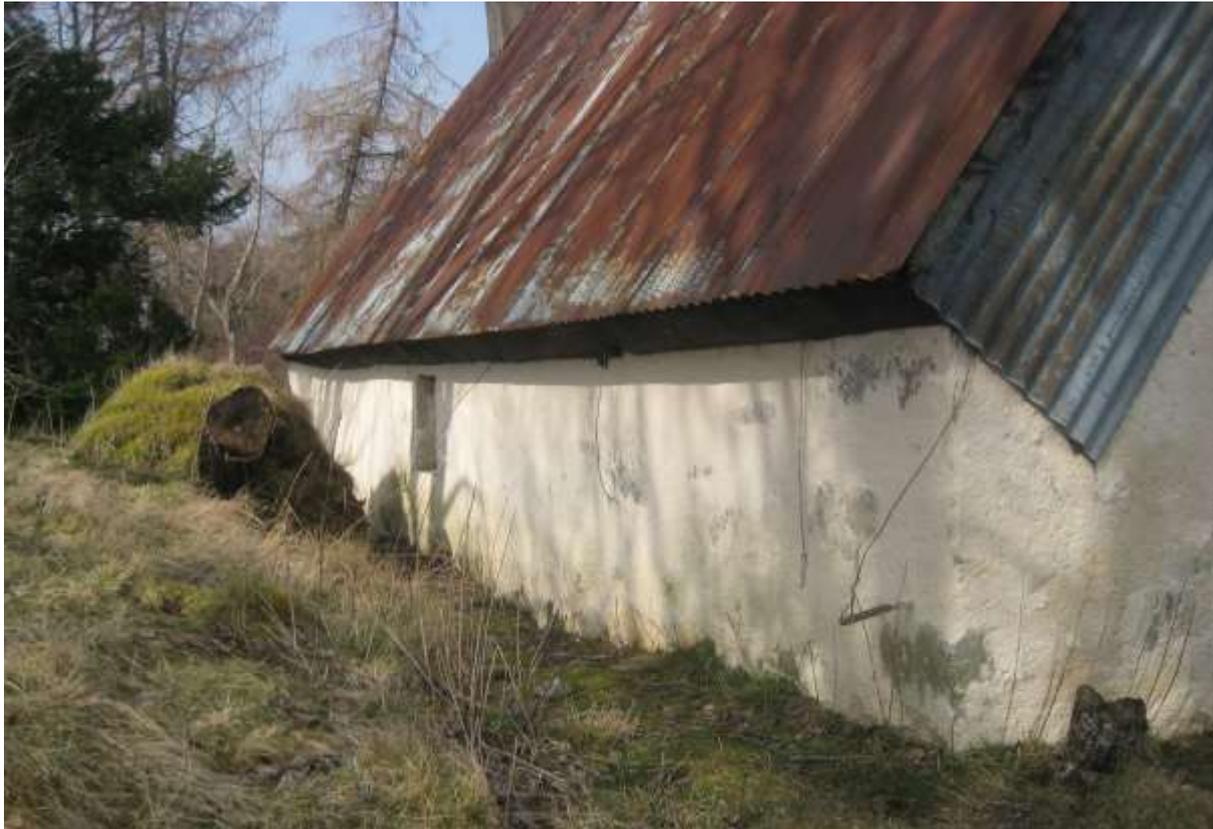
Figure 19. Completed limewash on the partly re-built south wall.

The repointed walls were protected with three coats of traditional lime wash, made up on site from quicklime and water (Figure 19). A small amount of tallow was added during the slaking to impart a degree of water resistance to the limewash.

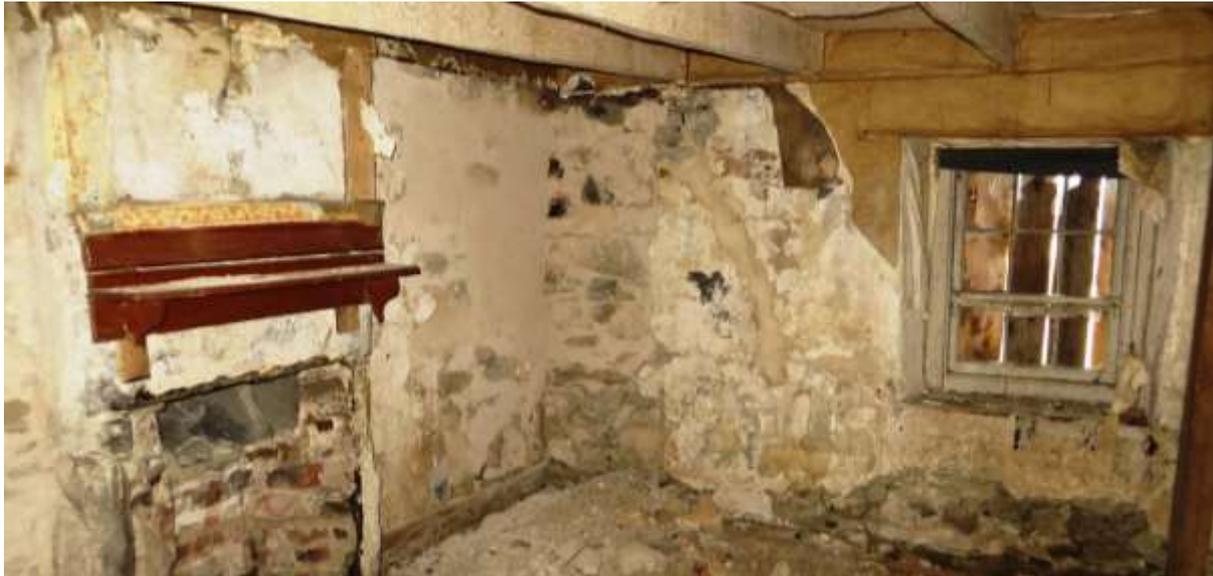
Internally, with the exception of the west bedroom, most walls were satisfactory, but in several places substantial re-pointing was needed due to leaching of lime mortar and settlement and displacement of individual stones. This was done first in order to consolidate the masonry prior to excavations into the floor for the under floor heating (Figure 20).

Figure 20. Completed re-pointing work in the parlour.

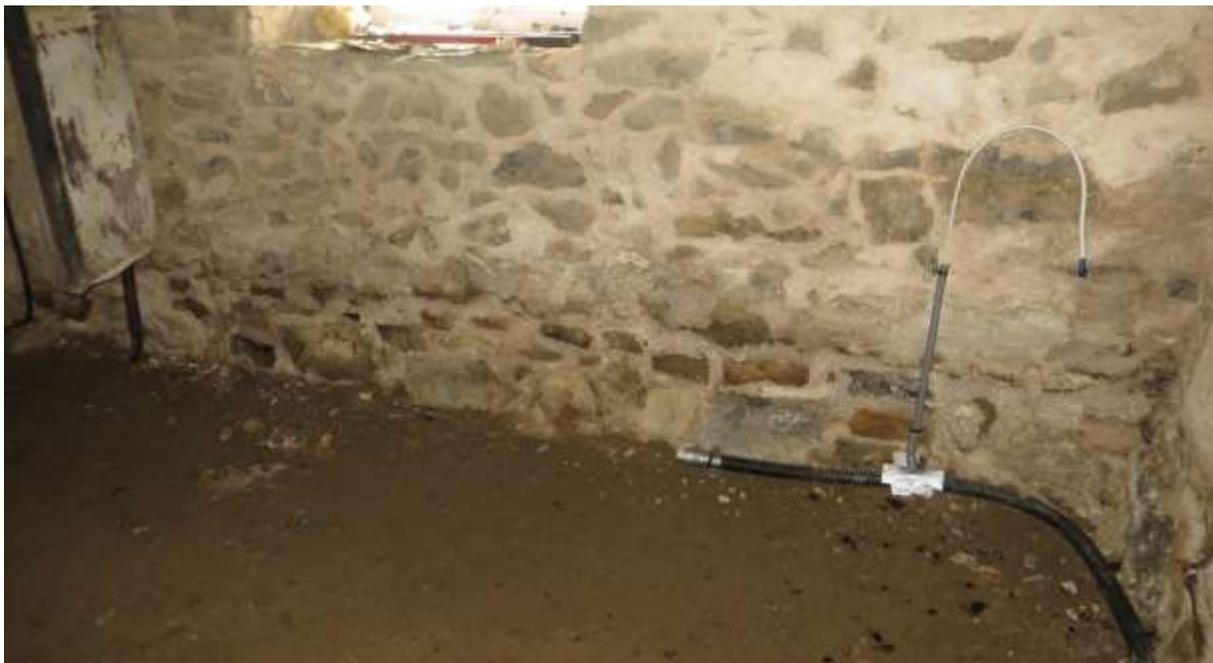
Figure 21. New masonry consolidation on the wall footings following the excavation of the floor.

An underfloor heating system supplied from a ground source heat pump was specified. This required the removal of the existing flagstones and the excavation of the floor, down to a depth of 400mm below the floor level. Part of this depth was required by the client to increase the room height. This was done by hand, and material was transported out in wheelbarrows. The depth of the excavation caused some apprehension for the contractor, fearing masonry movement due to removal of material at the base of the wall. In practice, for short periods (hours) exposing short lengths of wall in good condition on one side did not lead to issues. It was decided to excavate the floor in short sections (Figure 21), and additional masonry was built into the exposed footings of the wall.

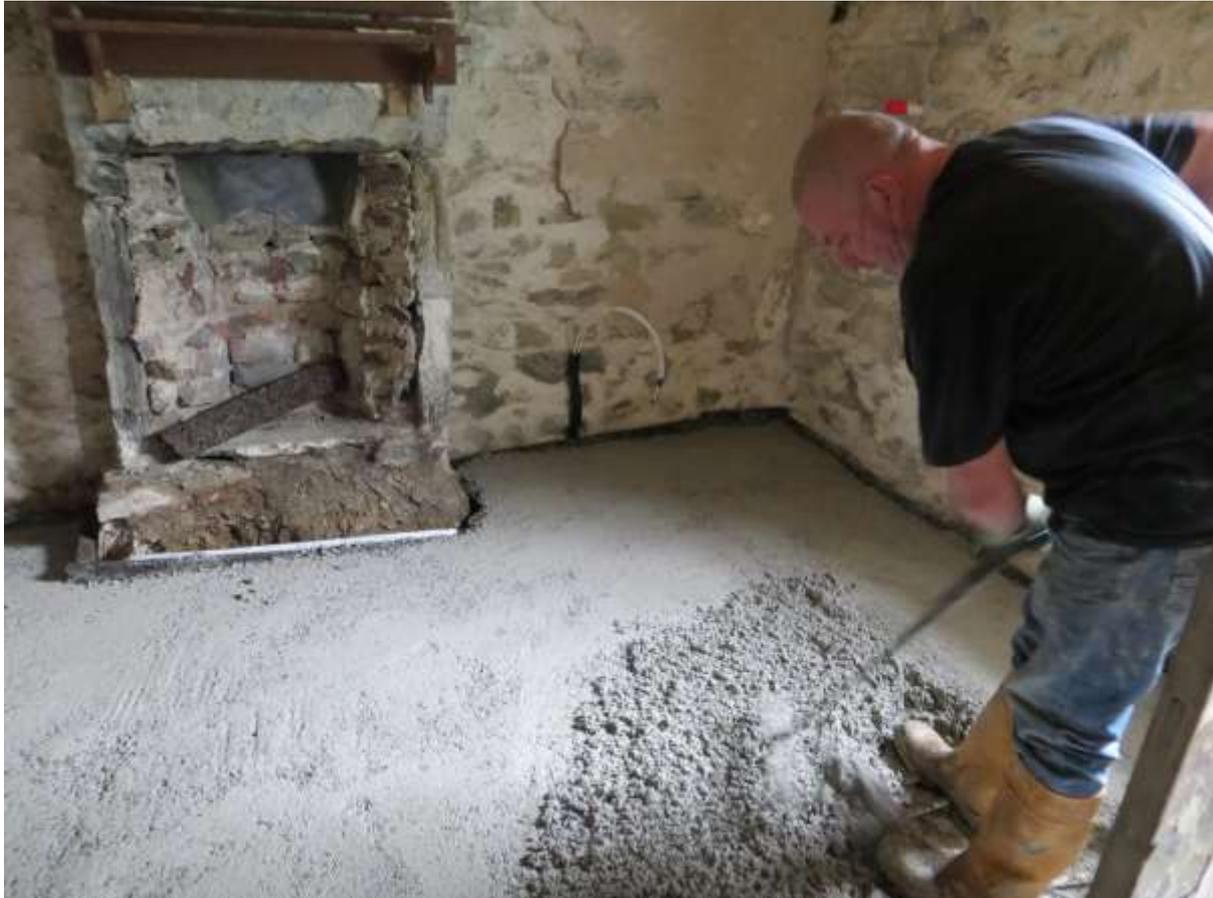
Figure 22. Laying the first lime concrete layer in the parlour. The final floor level was as the original at the height of the hearthstone.

An insulated lime concrete floor plate, designed for a heating loop, was laid in two layers to just below the final floor level (Figure 22). Level of the floor excavation was tapered up towards the walls to minimise excavation close to the wall foot. The floor consisted of an insulation layer of aggregate (expanded glass cobbles) overlaid with a geotextile membrane to provide a clean working surface, and enclosed with a 100mm lime concrete layer.

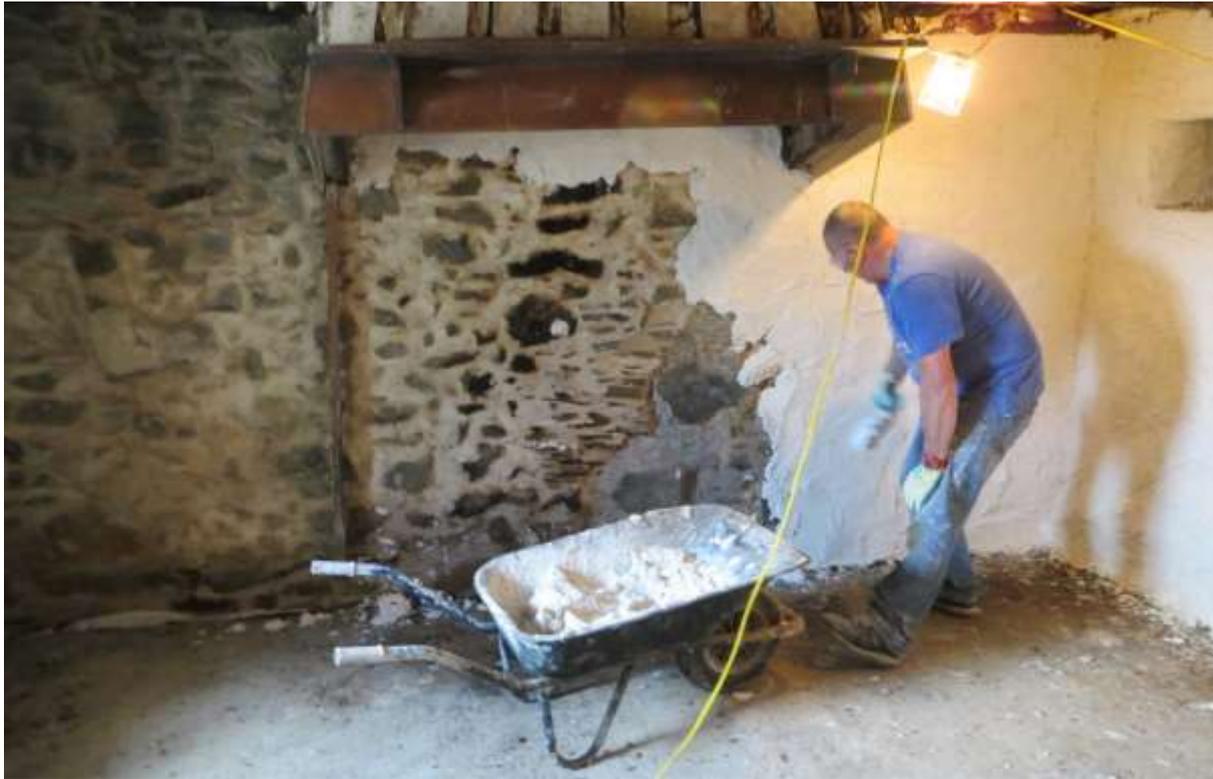
Figure 23. The first coat of insulated lime plaster being applied in the kitchen.

The building had originally been plastered on the hard; this plaster was in generally in poor condition, and on the rear wall it was entirely gone. The walls were re-plastered with an insulated lime plaster, applied in two coats to a thickness of around 60mm (Figure 23). This was intended to re-instate the original finish and provide improved insulation. Given the original thickness of about 35mm, an increase to a thickness of 60mm gave a very small reduction of internal volume. The vapour-open nature of the new plaster maintained the breathable construction of the traditional build.

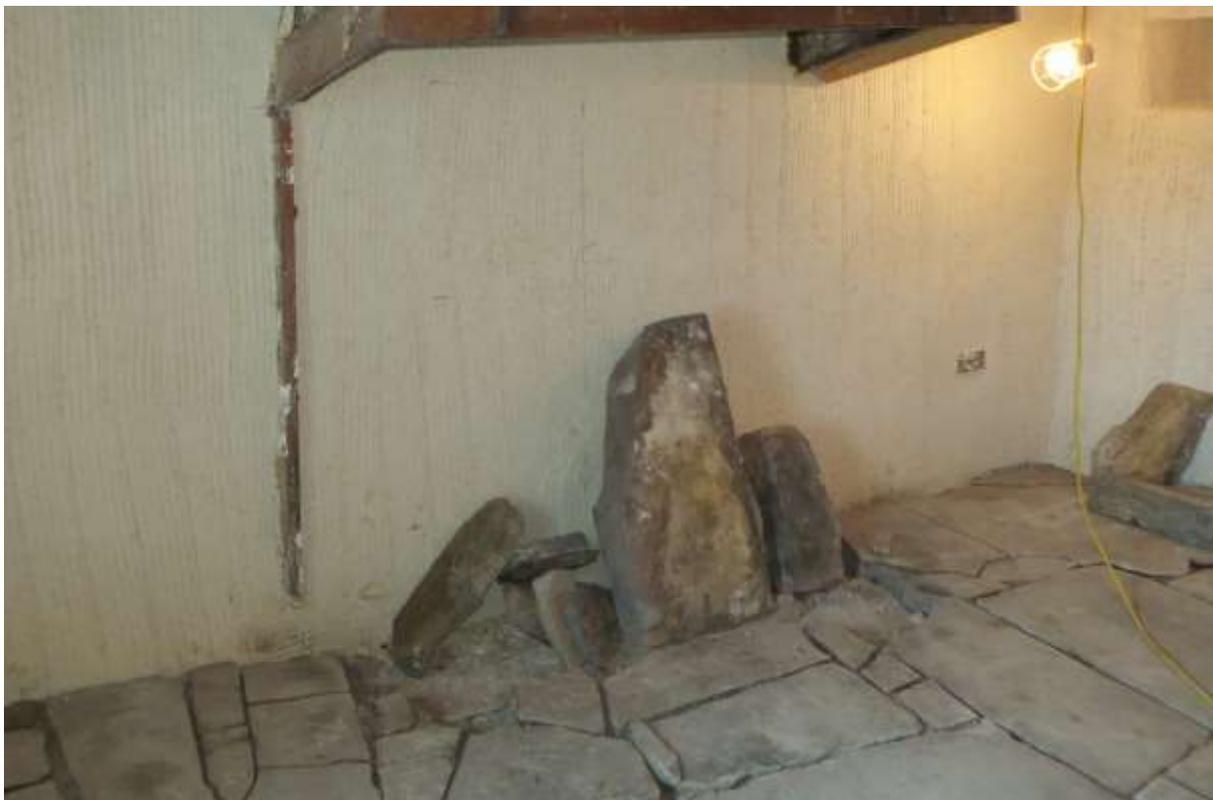
Figure 24. Re-laying the flagstones in the kitchen onto the insulated lime concrete.

The original flagstones had all been removed and numbered to allow their replacement in identical order and these were then relaid over the lime concrete slab, giving a floor finish much like the original (Figure 24)

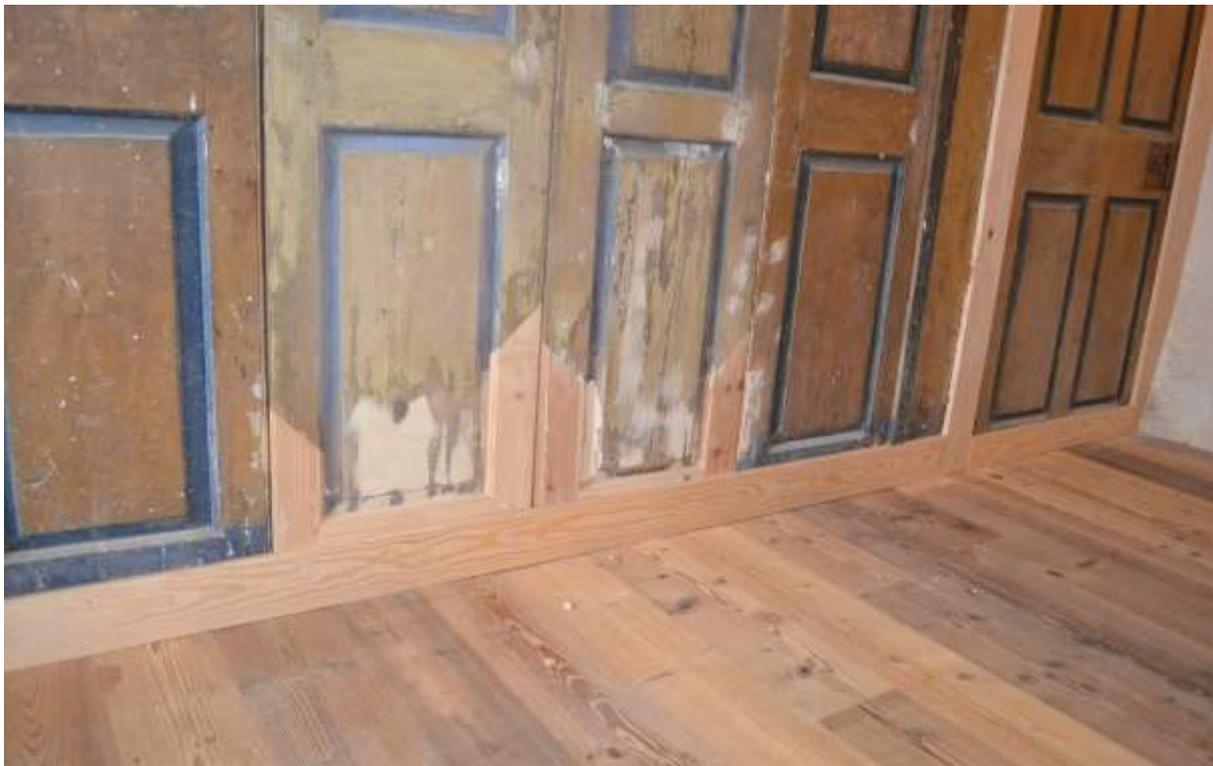
Figure 25. The new timber floor and the repaired box bed panelling in the west bedroom.

Where the lower sections of the box beds were in contact with the ground there were areas of timber decay. The damaged timbers were cut back, and new pieces were spliced on as seen in Figure 25. The splices used a diagonal joint that gives the best balance of strength and aesthetics. The new wood was a redwood of standard C17 grade, but care had been taken to allow it to settle in dry conditions before use. The bed frame on the kitchen box bed was retained and the area was re-upholstered as a form of sofa.

The original flagstone floor was only present in the kitchen and hallway, whilst the remainder of the ground floor had a timber floor, although as previously noted this had largely rotted away. In order to replicate the original floor finishes, the area of the previously timbered floors was made up with timber battens set into a lime concrete screed to allow fixing of replacement timber flooring. In order to ensure that the new timber flooring is unaffected by the underfloor heating, an engineered board was specified which comprised a softwood wearing-course bonded to a plywood tongue-and-grooved base which was fixed to the timber battens (Figure 25).

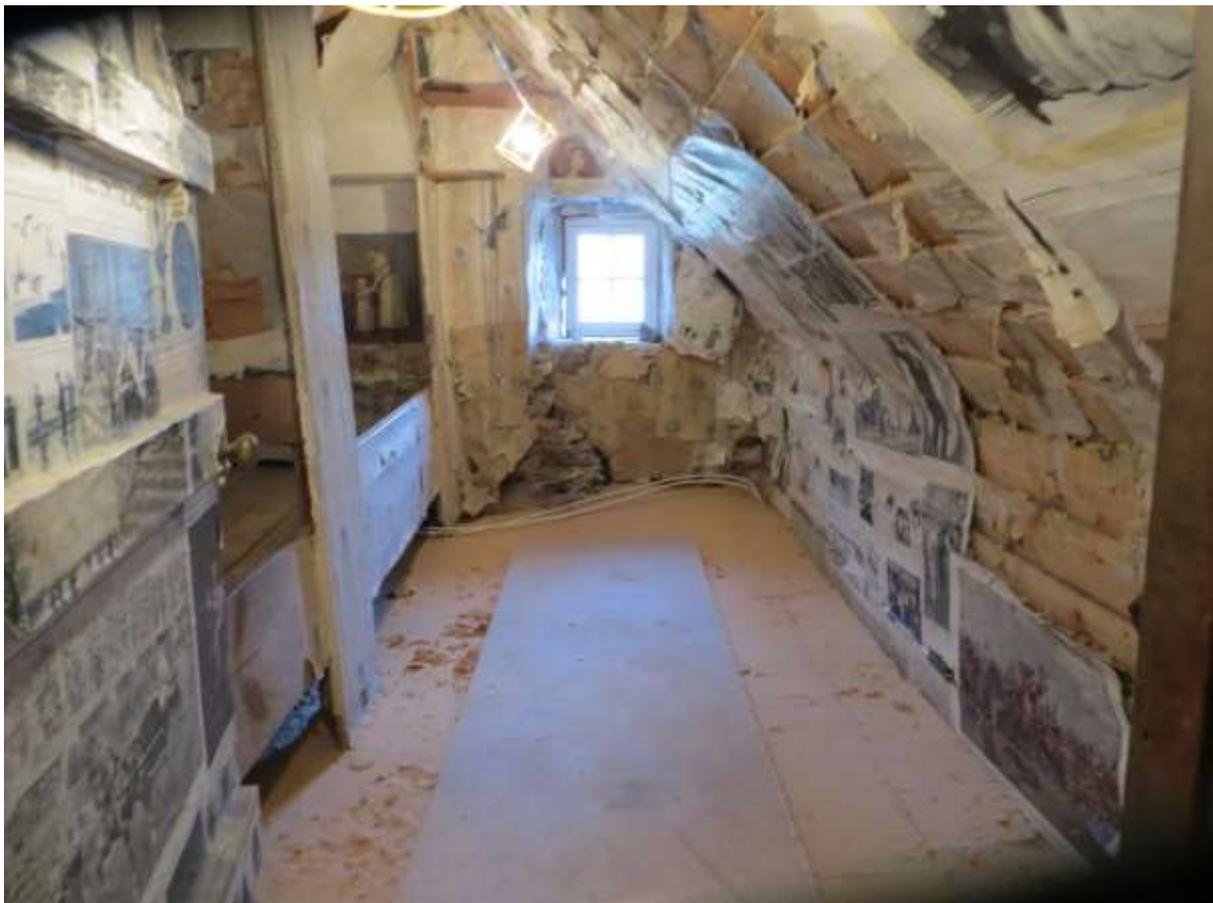
Figure 26. Wood fibre insulation laid on top of the floor in the attic rooms.

This area of the building was largely left as it was to be used for storage. A layer of wood fibre insulation was laid on top of the existing floor (Figure 26) to give a thermal break between the inhabited floors below and the cooler space above. The existing lapped boards, with their covering of paper illustrations, were left in situ. The door giving access to the stair was repaired and used to close off the attic.

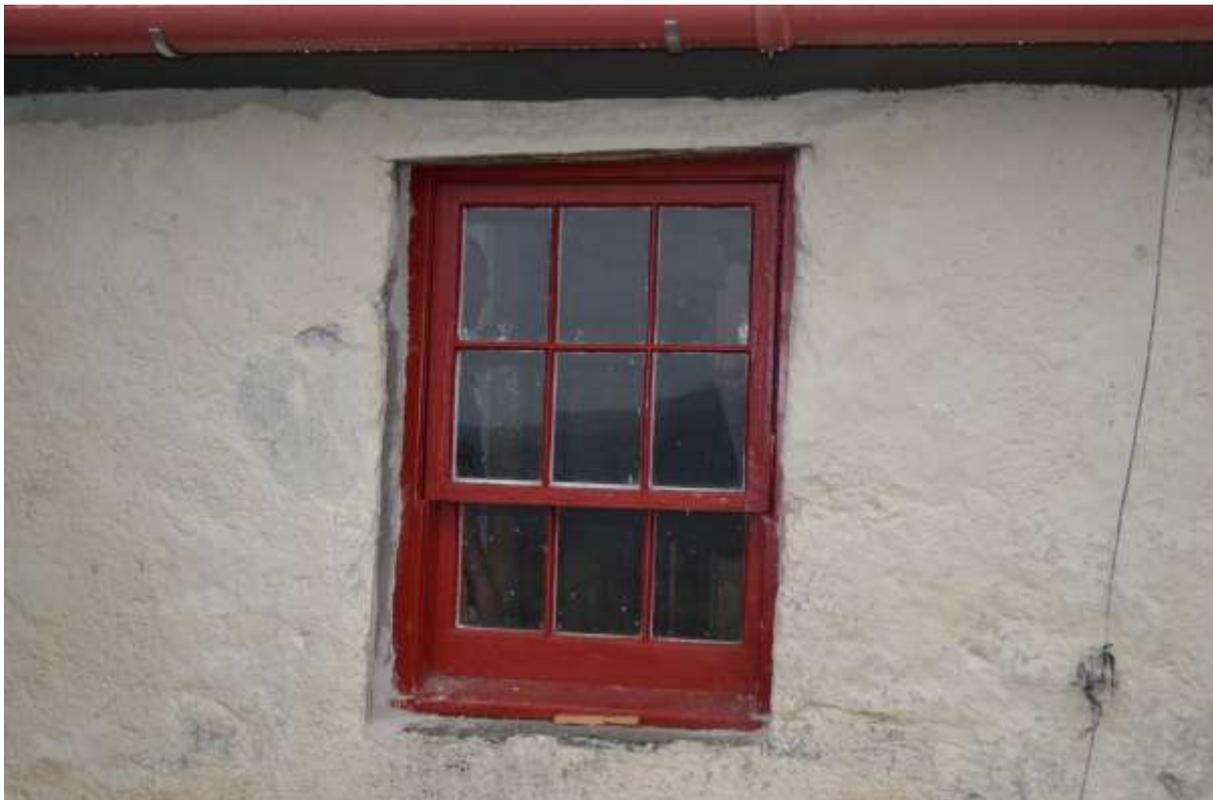
The two sash style windows appeared to be original and matched those pictured in the 19th century photographs. The upper sections were sound, but new cills and styles were required (Figure 27). Due to their small size, and their history, they were repaired like-for-like with no thermal improvement required by Building Control. There were no early glass panes remaining, nor the 'ancient knobble of glass' described by Nan Shepherd. Older glass, especially that from pre-1880 can be thin (down to 3mm), and it is likely to have been damaged at some point. Modern float glass, 6mm thick was used in repairing both sash windows.

Figure 27. The repaired parlour window, following adjustment for use as a fire escape.

In order to comply with Building Control requirements to ensure that the building could be evacuated via the windows in case of fire in the porch, the upper sashes had to be adapted to form casements; this require Listed Building Consent.

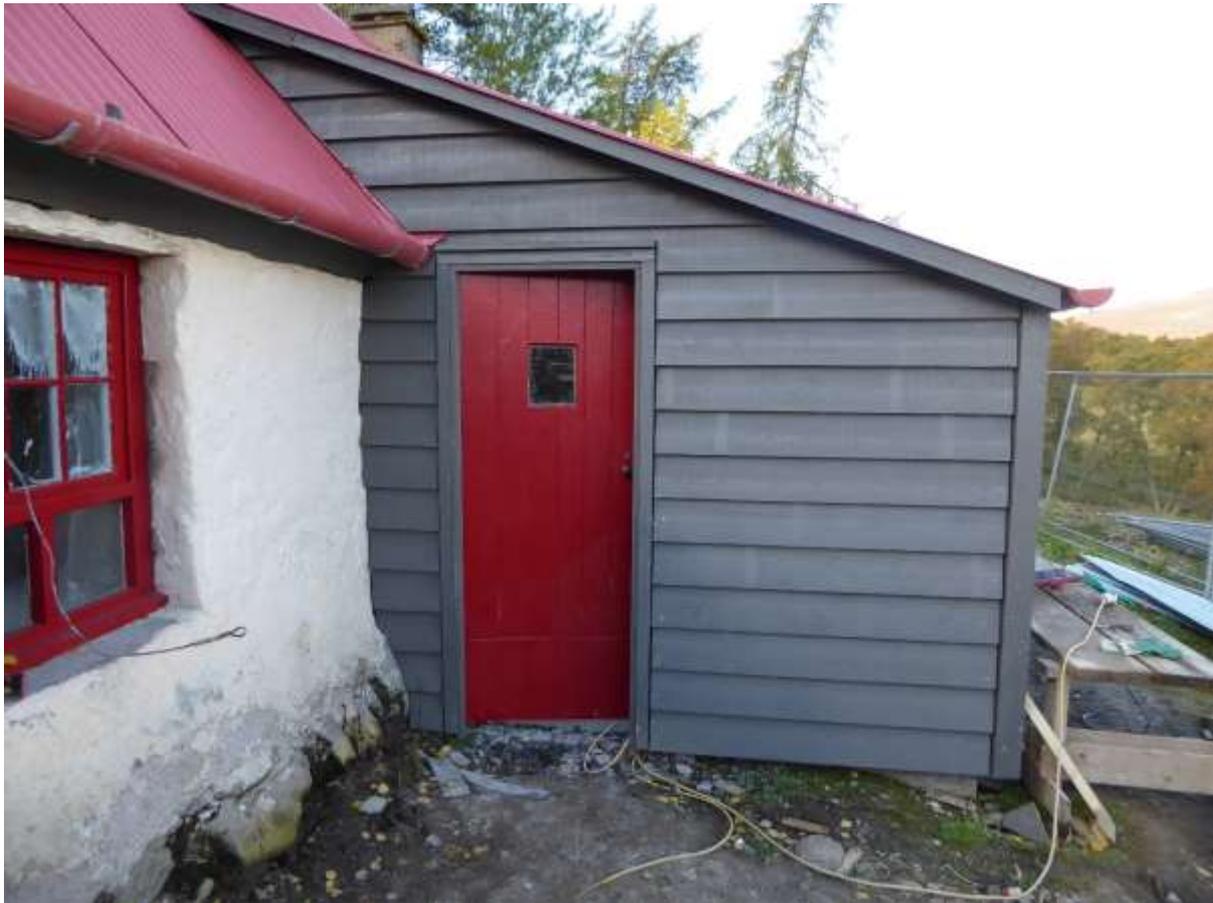
This additional feature, probably from the late-19th century, appeared sound but was found to have rotted considerably at ground level. While it was to be retained as part of the Listed Building Consent, it required additional work in order to be re-configured as a kitchen; it was therefore entirely rebuilt on a new foundation (Figure 28).

Figure 28. The rebuilt porch, on the original footings and to the same profile, which became the kitchen.

Wood fibre-board was fitted between the new framing to provide insulation, and new larch boarding was fastened to the exterior in the same manner as the original.

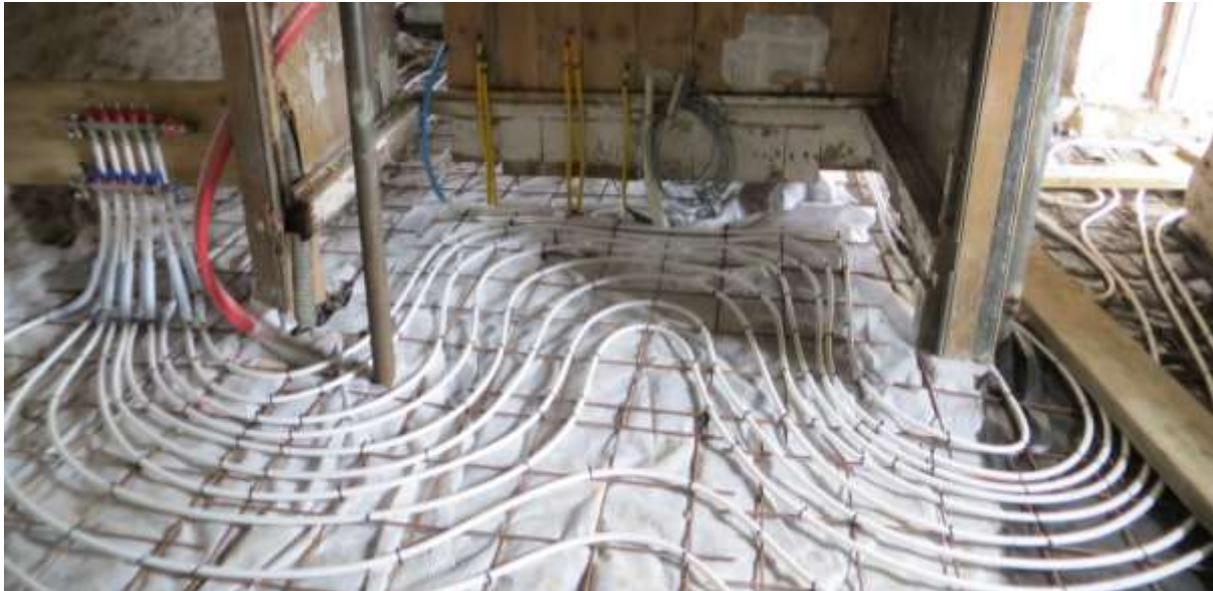
Figure 31. The heating coil fixed in place prior to the final lime concrete layer.

The underfloor heating matrix for the ground source heat pump was fixed to steel reinforcing mesh as the proprietary fixings supplied would not sit accurately on the lime concrete insulation layer (Figure 31). A smooth lime concrete floor slab was then laid encapsulating the heating coils.

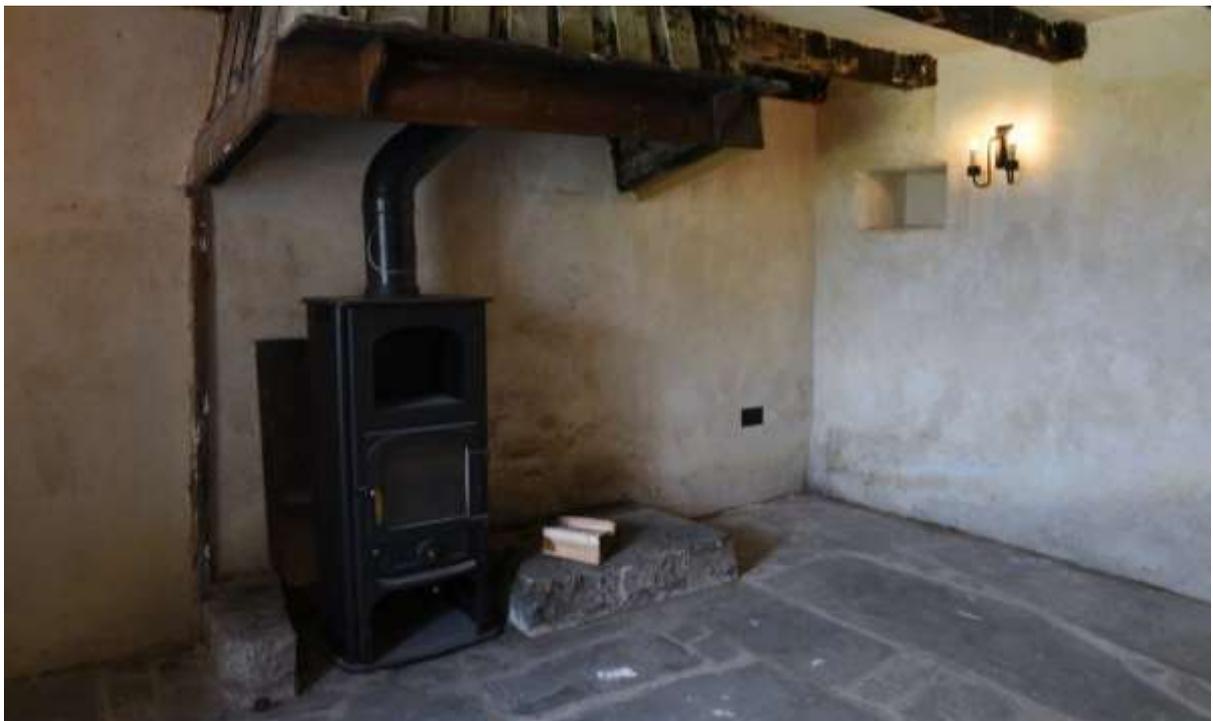
Figure 32. The new wood burning stove in the hearth below the hanging lum

The client also wanted to augment the under floor heating with a wood burning stove that could raise the temperature quickly in the kitchen if required. This was located in the kitchen, on the footprint of the hearth below the hanging lum (Figure 32). A modern double skinned flue was fitted within the existing timber of the hanging lum. This allowed the safe use of a fire in the building.
