Downie's Cottage, Braemar

Repairs and upgrades to a Highland cottage

This publication should be quoted as:
Historic Environment Scotland
Refurbishment Case Study 22

Roger Curtis

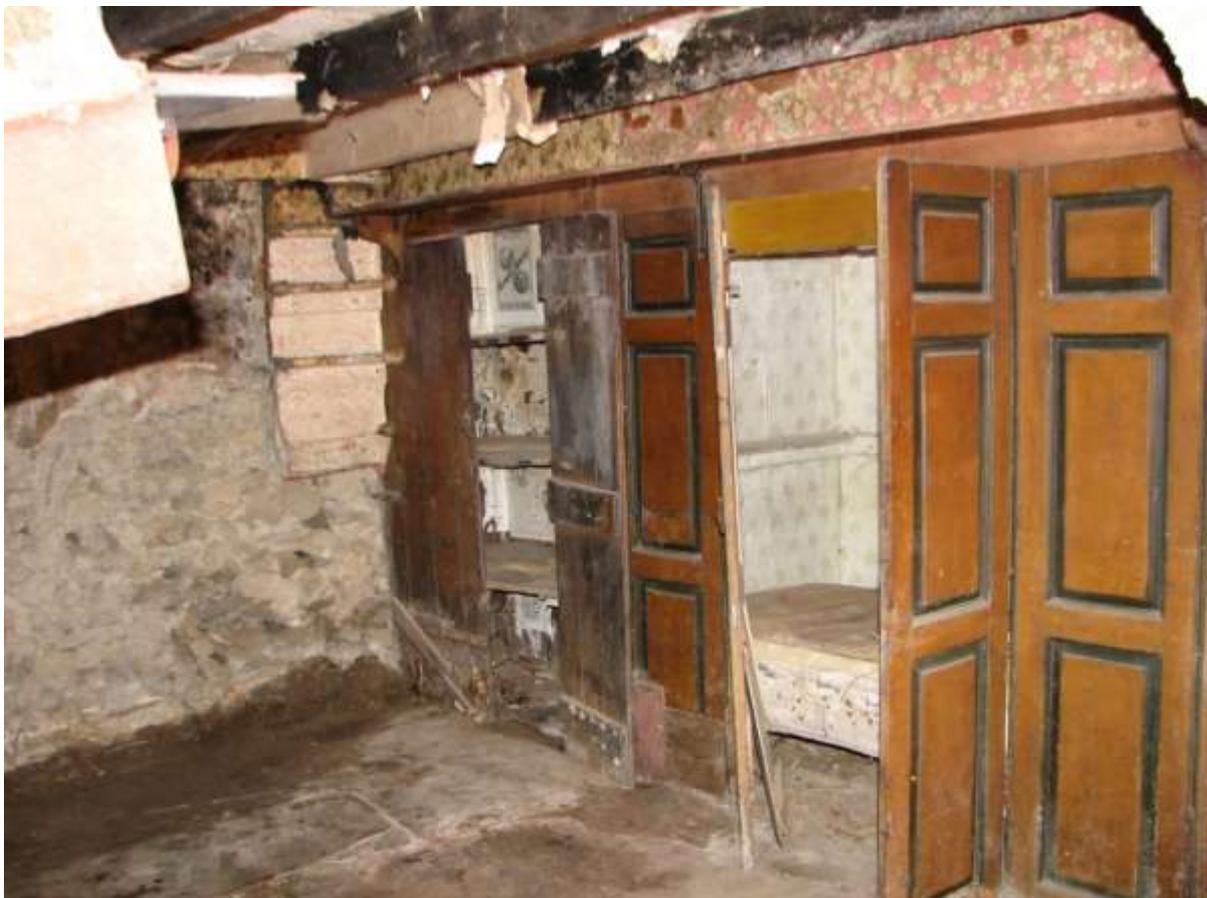
Figure 11. The box bed in the kitchen. Note the straw filled mattress just visible through the open shutter leaf.

Where the lower sections of the box beds were in contact with the ground there were areas of timber decay. The damaged timbers were cut back, and new pieces were spliced on as seen in Figure 25. The splices used a diagonal joint that gives the best balance of strength and aesthetics. The new wood was a redwood of standard C17 grade, but care had been taken to allow it to settle in dry conditions before use. The bed frame on the kitchen box bed was retained and the area was re-upholstered as a form of sofa.

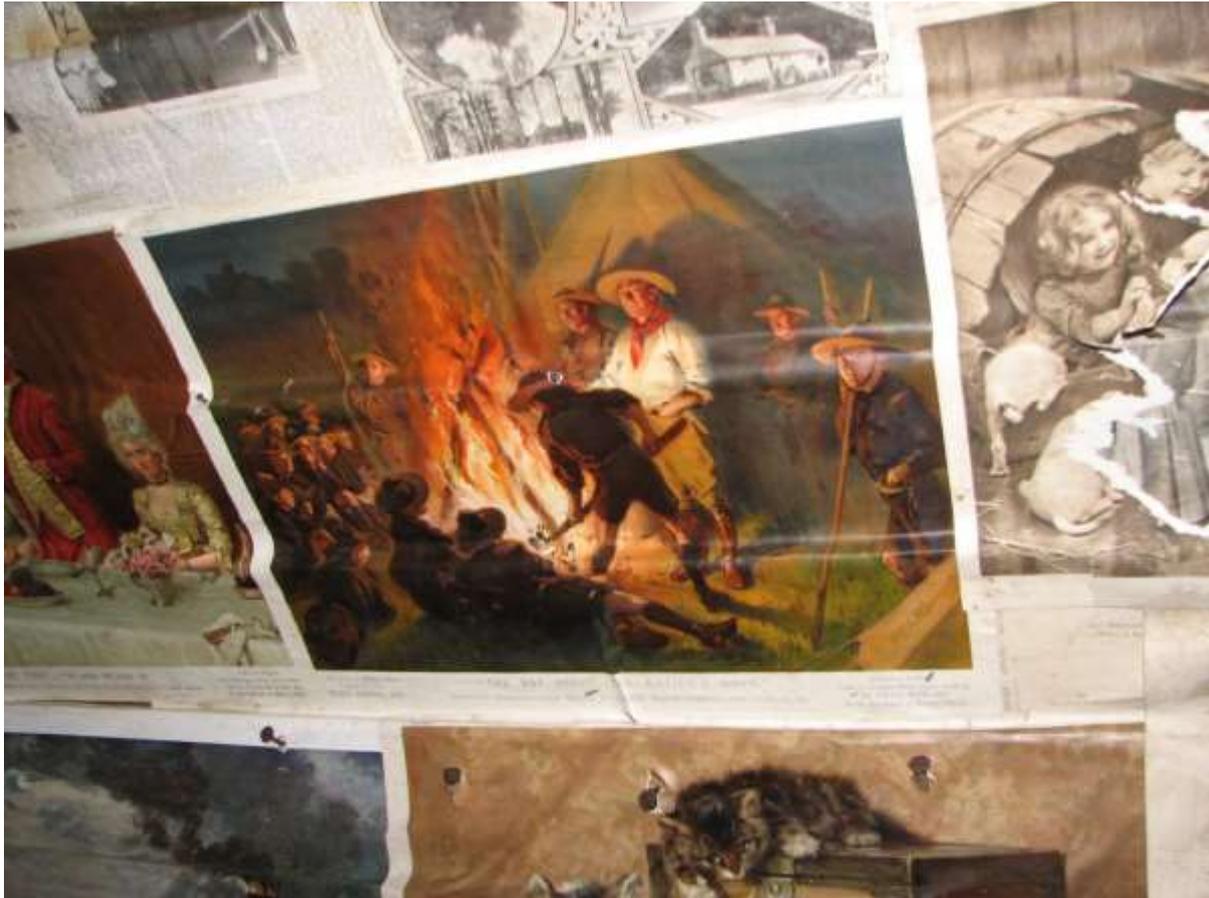
The stairwell and the two sleeping areas under the roof, while modest in scale, were interesting due to their unusual decoration. The inside was lined with rough sawn planks fastened horizontally to the roof structure; this in turn was covered almost entirely with illustrations, coloured and monochrome, from picture magazines dating from the 1890's to the early-20th century. While of modest fiscal value, their excellent condition in-situ gives them a significant cultural worth. Despite the house being unoccupied for nearly 80 years, unheated, with areas of damp downstairs, the paper illustrations appeared as fresh and bright as when they were pasted on (Figure 13). It is likely that the stable conditions provided by the insulation and thermal buffering of a thick layer of thatch prevented any fast changes of temperature, preventing condensation and subsequent damage. The absence of any significant light apart from that provided by a small peep window meant that there was no fading of the inks from light damage.

Figure 13. The wall coverings on the stairwell partition; their survival is unusual.

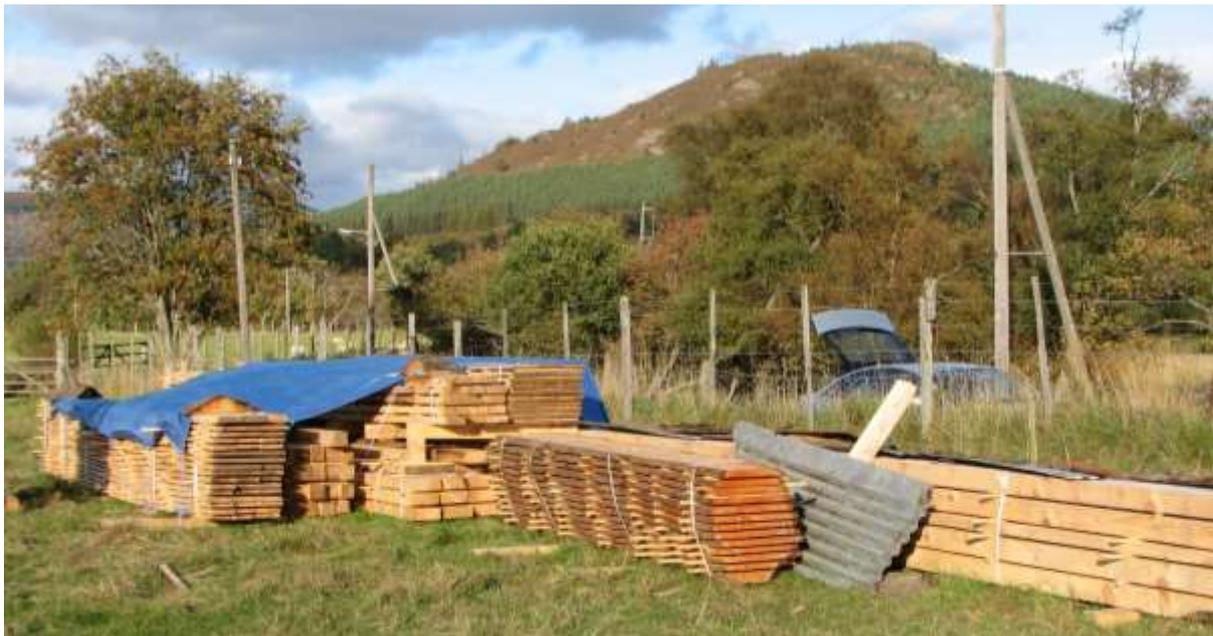
Figure 14. Sawn balks of timber from the cleared trees.

The stand of Douglas Fir and Spruce that had enclosed the site for 60 years had become unstable and subject to windblow, and was felled. The timber was of good quality, and converted to planks and other dimensions with a portable 'Miser Saw' giving some useable timber (Figure 14). There was an aspiration by the client to utilise this material in the repairs to the byre and the construction of a new property close by; unfortunately for reasons relating to building warrant compliance requiring the certification of timber used in construction this proved unfeasible. However, this timber was used for non-structural repairs to the property. The use of local timber in construction is a current issue, and with appropriate grading and certification it is possible, although in this case time and resources did not allow it.

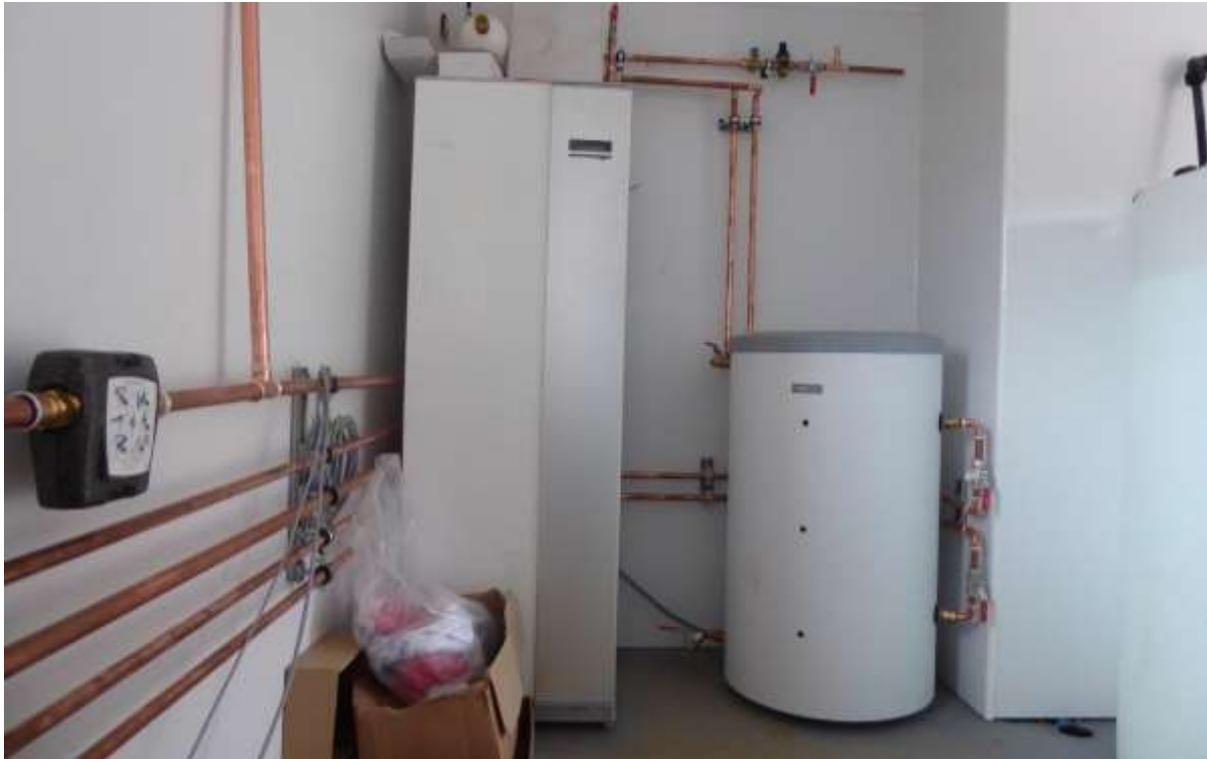
Figure 29. The heat exchanger and other equipment in the restored byre.

Due to the size of the croft being too small to fit the plant, the heat pump unit and associated tanks and vessels were located in the restored byre building close by, with insulated pipework linking the buildings (Figure 29). The system works by extracting thermal energy stored in the earth and this is collected by fluid circulating through underground pipework. The system specified required 400 metres of collector loop to be buried approximately 1.2 metres below the surface. This is now a standard specification, although involves large plant and equipment. The trenches

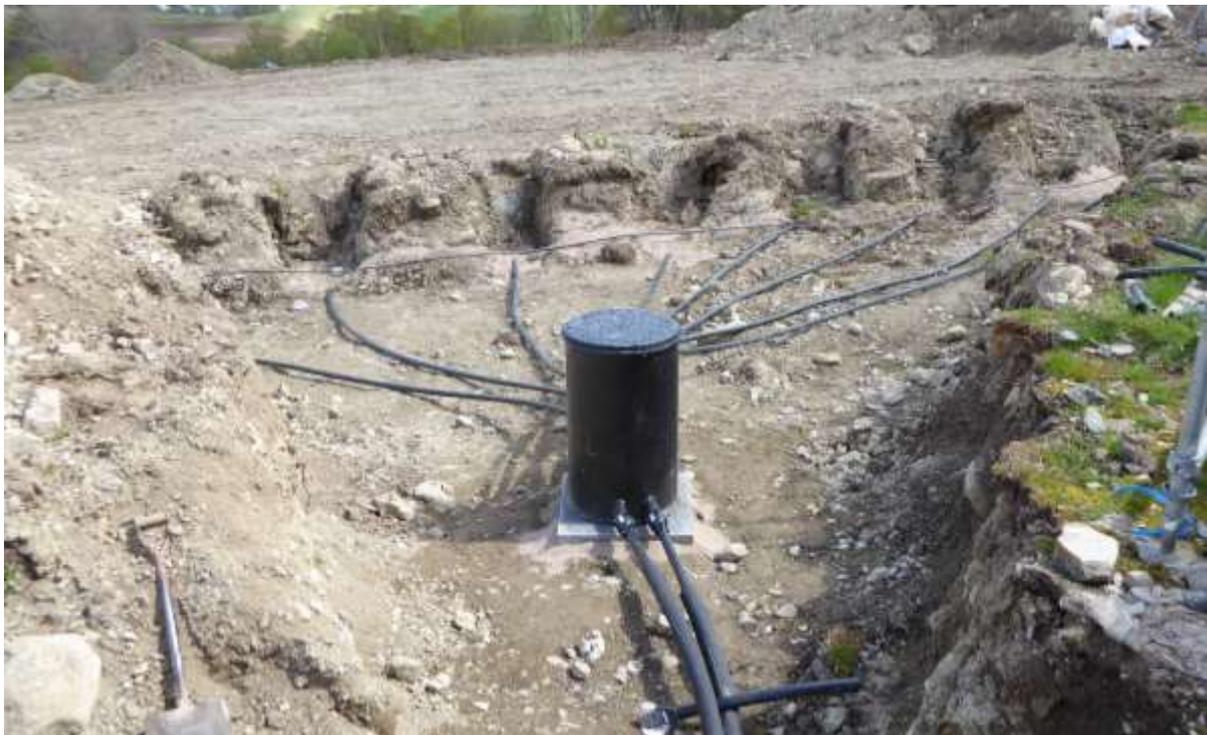
Figure 30. The junction or collector for the ground source heat pump coils laid in the field to the north east of the croft house.

were dug in the field to the north east of the croft house (Figure 30). In some circumstances there will be considerations regarding buried archaeological remains; an assessment of the site indicated that this was most unlikely. In this instance, nothing was encountered.

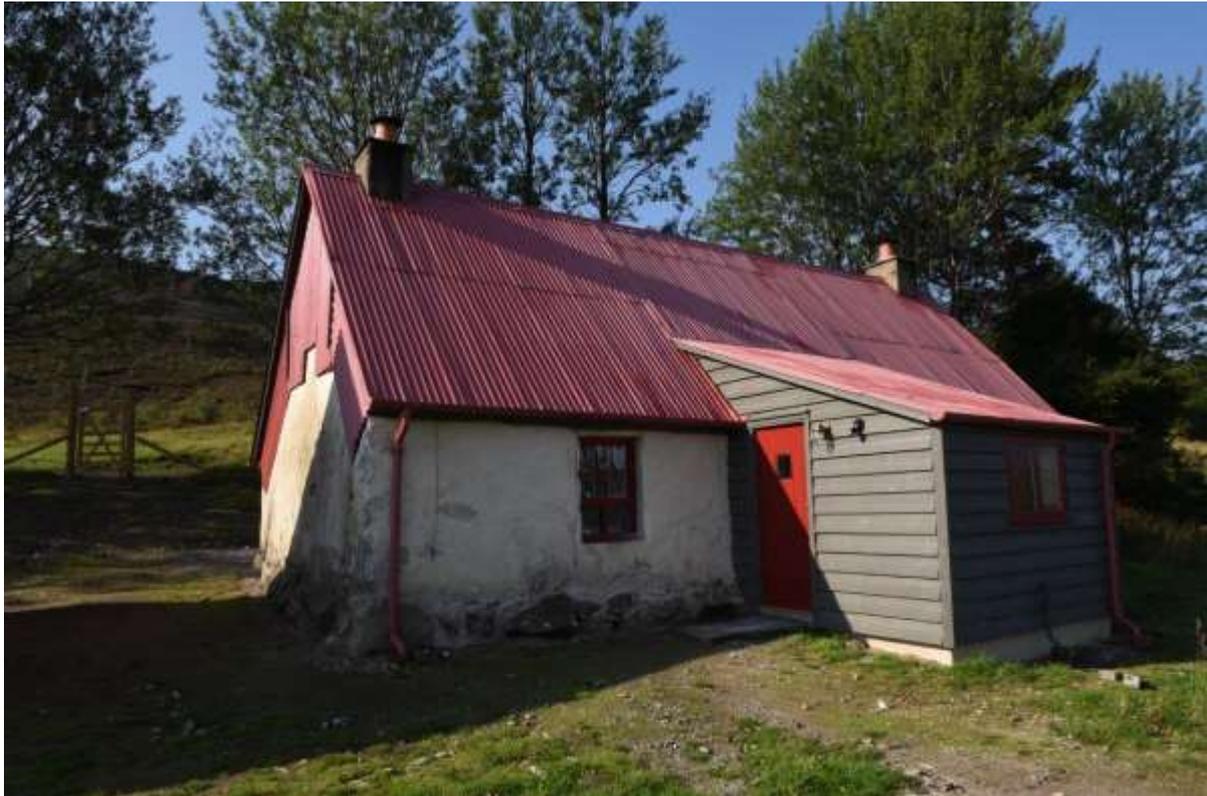
Figure 33. The croft house viewed from the southeast in September 2016 following completion of works in July of that year.

The building has been successfully upgraded and brought back into use. Damaged and defective items have been repaired and improved using traditional materials and techniques. Historic finishes have been retained while modern services have been
